Arborist Report

Title: **Amberleigh HOA – Level 1 Limited Visual &
Level 2 Basic Tree Risk Assessment**

Prepared for: **Amberleigh HOA**
Attn: Mark Beales, Amberleigh HOA Board President
1820 163rd Street SE
Mill Creek, WA 98012

Date: April 21, 2025

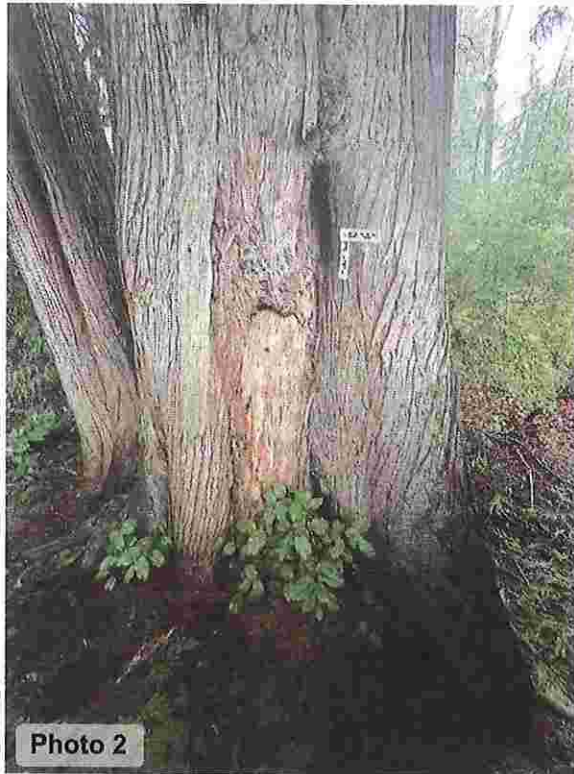
Tree Condition	
Tree ID	Condition notes
136	There is a large wound on the south side of the trunk (Photo 2).
137	This is a dead tree that leans slightly towards Mill Creek Road.
138	This is a dead-standing tree.
139	There is an occluded ² wound on the trunk at an approximate height of ten (10) feet.
140	Sprouts are growing from the remaining stump. Remove sprouts and girdle base to prevent future problematic growth. This tree was not included in the ISA Level 2 assessment.
141	Small amount of pitch oozing on the east and west sides of trunk.
142	Dead-standing tree with several mushroom conks growing on the trunk.
143	Multiple leading stems with narrow attachments. Black crust like fruiting bodies, consistent with brittle cinder fungus, are growing on the base of the trunk.
144	Two (2) leading stems with narrow attachments and included bark ³ .
145	Dead-standing tree.
146	The branch that extends southeast towards houses has developed a crack at the attachment (Photo 3). The crack is approximately one (1) inch wide.

Photos 2 to 5. Photo 1 shows the large wound on Tree 136. A crack has developed at the attachment point of a large stem on Tree 146 (Photo 2). Brittle cinder fungus is growing on Tree 143 (Photo 3). Ganoderma conks are growing at the base of Tree 149 (Photo 4). The white ruler in Photos 1, 3, and 4 is four (4) inches long.

Test 1 was performed at the large wound on the lower trunk. Wood density appears normal to a depth of four (4) inches, after that there is a complete drop in the density reading to the end of the test which indicates possible advanced decay or a cavity.

Test 2 was performed perpendicular to the wound on the lower trunk. Testing indicated decay at a depth of 3.5 to 7 inches and at a depth of 9 to 16 inches.

I recommend that both trees be retained and inspected using ISA Level 3 Advanced Assessment methods in three (3) years from the date of this report.

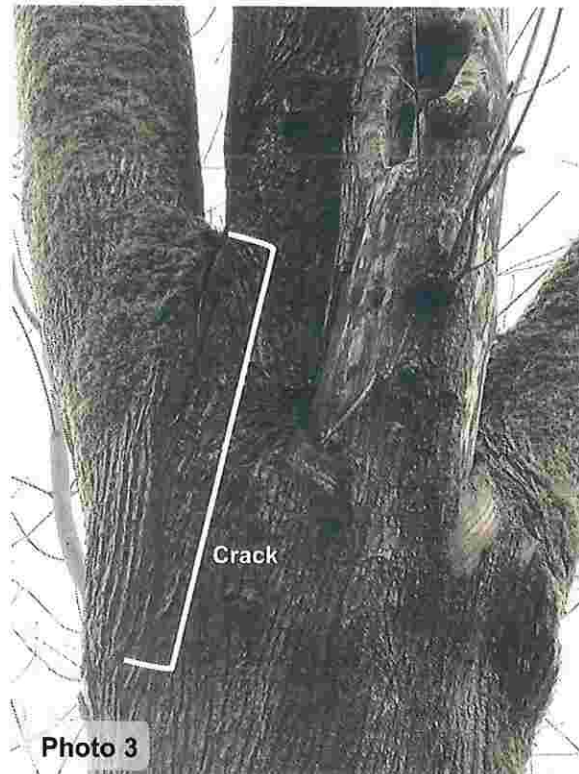
146	Bigleaf maple (<i>Acer macrophyllum</i>)	32.0	80	The branch that extends southeast has developed a crack at the attachment to the parent stem. There are multiple past branch failures.		Imminent		High		Severe		Extreme		Crown & branch reduction	
147	Bigleaf maple (<i>Acer macrophyllum</i>)	21.3	60	Multiple leading stems and there is extensive decay in the lower trunk where the stems diverge. One stem leans toward Seattle Hill Road.		Probable		Medium		Significant		Moderate		Convert to snag	
148	Western red cedar (<i>Thuja plicata</i>)	37.1	70	There are several wounds in the tree that appear to be man-made. Much of the exposed wood is solid.		Improbable		Medium		Severe		Low		Monitor	
149	Bigleaf maple (<i>Acer macrophyllum</i>)	17.2	34	There are several mushroom conks growing at the base of the trunk. The tree leans slightly towards residences located within Amberleigh HOA.		Probable		High		Significant		High		Remove

Crown & Branch Reduction – Tree 146

- Reduce the length of the stem that extends towards 1923 163rd Street SE by two-thirds. The stem has a one (1) inch crack at the attachment point and is oriented to the southeast.
- Reduce the height and canopy spread of the tree by 20 percent.
 - Structural pruning principles shall be applied to reduce codominant stems.
 - Multiple years of pruning treatments may be necessary to complete crown reduction to avoid pruning more than 20 percent of the crown in one (1) year.
- Final cuts shall be made outside the branch collar, do not make flush cuts or leave branch stubs.
- Maintain a balanced canopy and natural tree form.

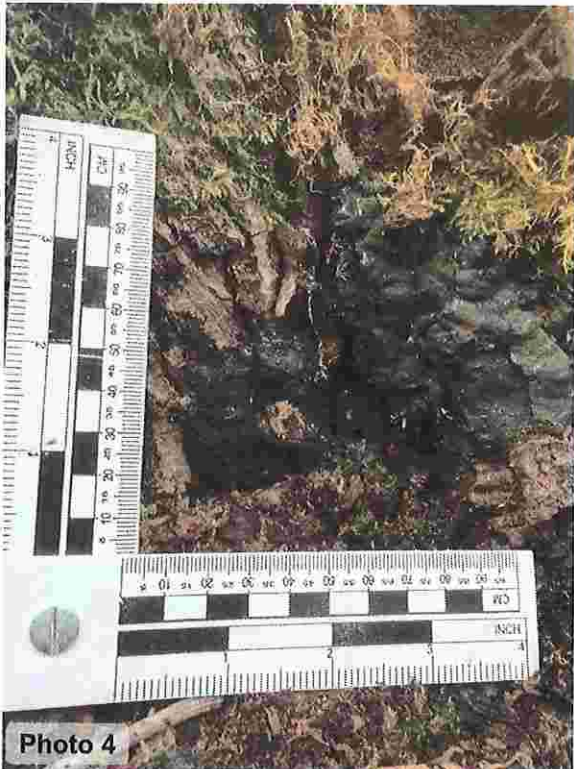
- Tree 136 – There is a large wound with visible signs of decay. I was unable to determine the extent of the decay using Level 2 assessment methods.
- Tree 143 – I observed brittle cinder fungus (*Kretzschmaria deusta*) growing at two (2) locations on the lower trunk. Brittle cinder fungus feeds on living wood which can lead to failure of the infected tree part. I was unable to determine the structural condition of the lower trunk using Level 2 assessment methods.

A small and isolated pocket of decay was found during two (2) resistance drilling tests. The pocket of decay was approximately two (2) inches wide and began at a depth of 10.5 inches into the trunk of the tree.

Tree 143

- Reduce the length of one (1) branch by two-thirds. The branch extends towards the residence 1831 163rd Street SE and is oriented southwest.
- Prune the branch back to a viable lateral branch.
 - If a proper reduction cut back to a viable lateral branch is not possible, then remove the branch back to the branch's bark collar at the parent stem.
- Final cuts shall be made outside the branch collar; do not make flush cuts or leave branch stubs.
- Do not reduce the height of this tree.

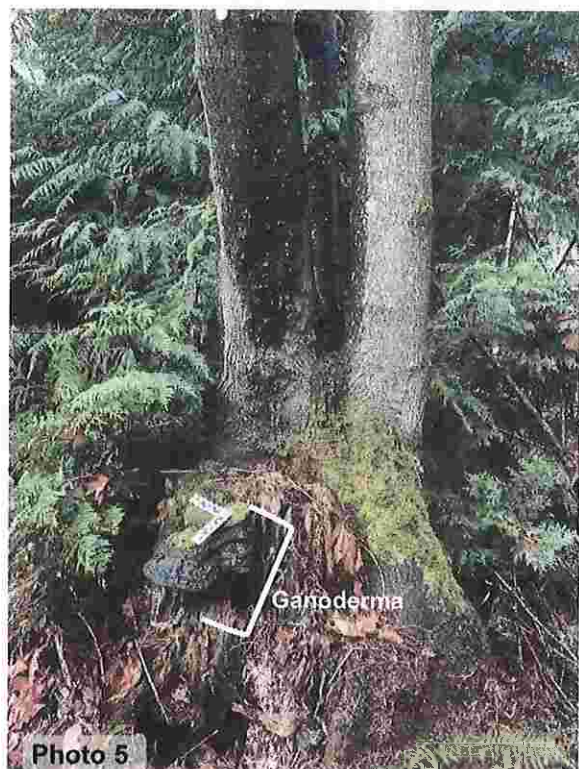
147	Multiple leading stems and there is extensive decay in the lower trunk where the stems diverge.
148	There are several wounds in the tree that appear to be man-made. Much of the exposed wood is solid.
149	Several <i>Ganoderma applanatum</i> conks are growing on the base of the trunk (Photo 4).
150	The tree has a corrected lean and the trunk is covered in ivy.
151	The trunk has a slight lean to the north that is uncorrected.
152	Multiple leading stems that are narrowly attached (Photo 5).

Tree 152

- Reduce the length of one (1) branch by two-thirds. The branch extends towards the residence at 1800 Mill Creek Road Unit 14-D and is oriented northwest.
- Prune the branch back to a viable lateral branch.
 - If a proper reduction cut back to a viable lateral branch is not possible, then remove the branch back to the branch's bark collar at the parent stem.
- Final cuts shall be made outside the branch collar, do not make flush cuts or leave branch stubs.
