Arborist Report

Title: **Amberleigh HOA – Level 1 Limited Visual &
Level 2 Basic Tree Risk Assessment**

Prepared for: **Amberleigh HOA**
Attn: Mark Beales, Amberleigh HOA Board President
1820 163rd Street SE
Mill Creek, WA 98012

Date: April 21, 2025

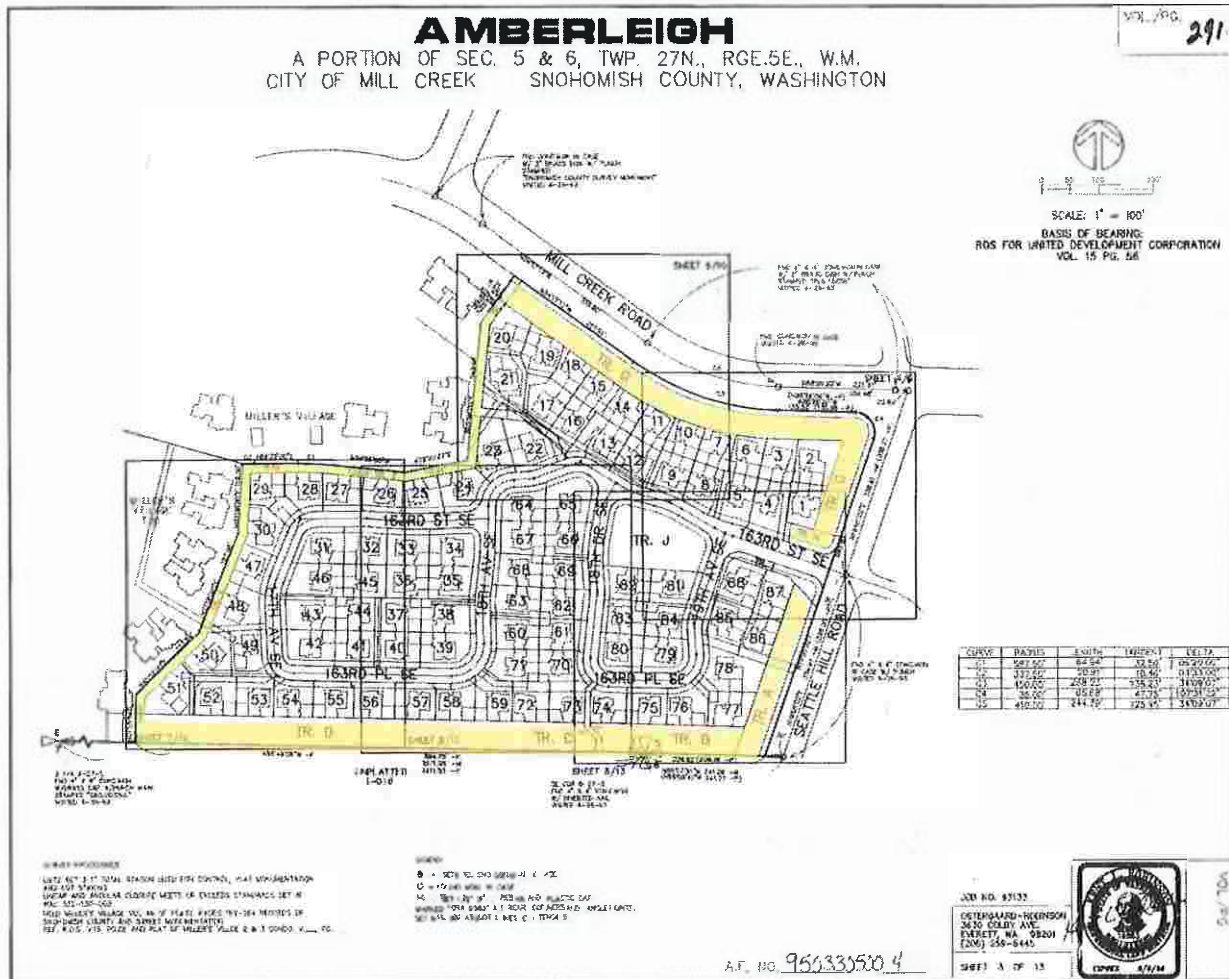
From my discussions with Mark and my review of the plat map available on the HOA's website, it is my understanding that the cutting preserve and landscape buffer (Tracts A to H) border the entirety of Amberleigh HOA and, at its greatest extent, reaches 50 feet beyond private residences located within the HOA (Map 1).

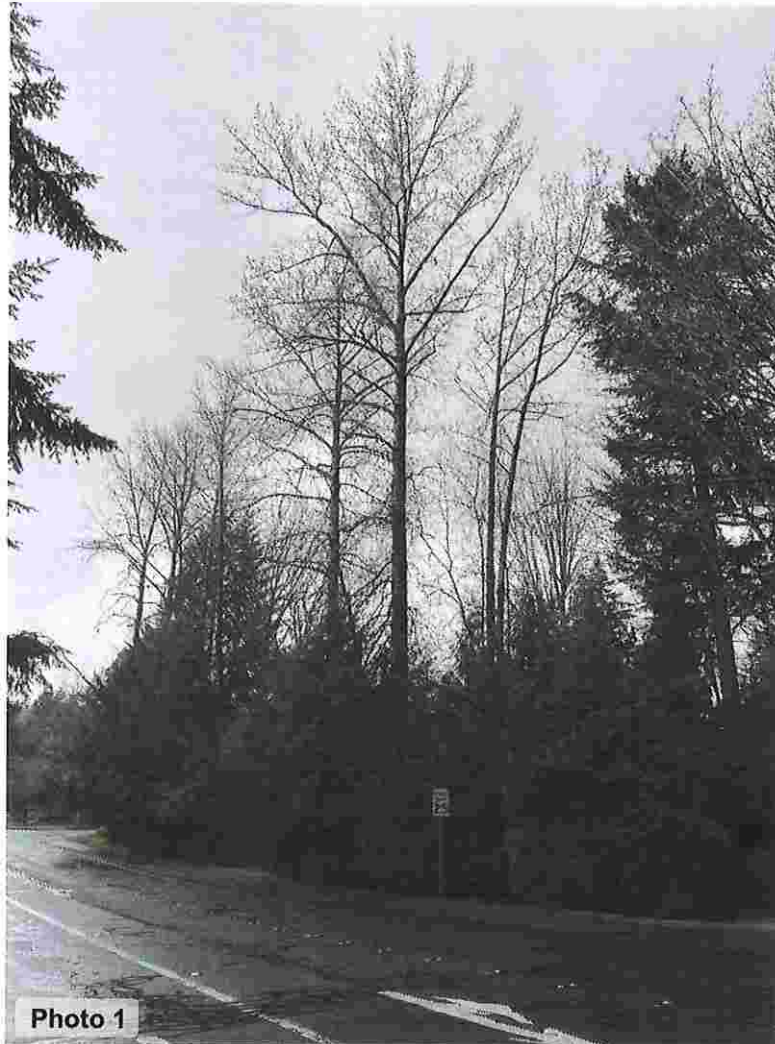
Photo 1. Tract G included several native tree species. The viewer is on Seattle Hill Road looking southwest.
